Report on the investigation of the
inadvertent release of carbon dioxide and disabling of

Figaro

off Wolf Rock

Report No 14/2008
August 2008

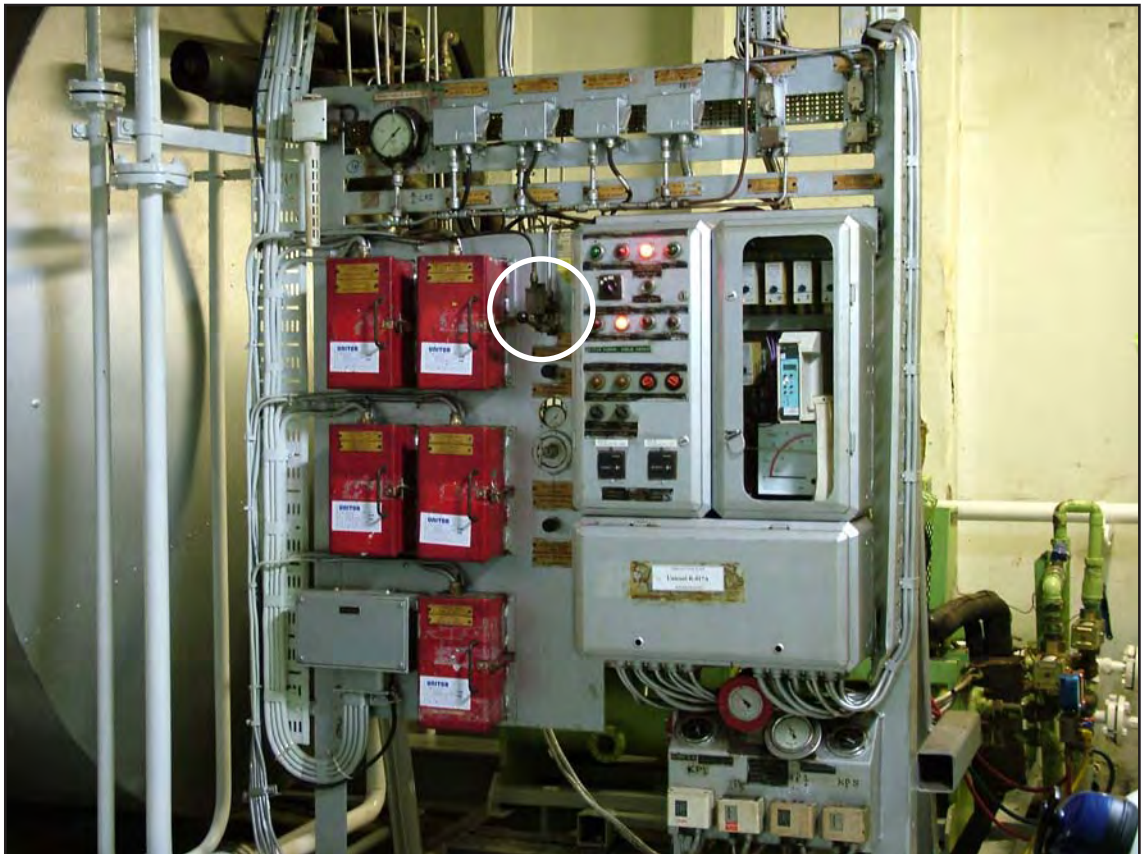
Figure 3

The EE opened all five of the cabinets in sequence and operated the main and distribution valve remote controls. The 3E, stationed in the CO₂ compartment on deck 5, reported via radio that he could not see any of the corresponding valves in the system operating. The CE, EE and 2E went to the CO₂ compartment on deck 5 and attempted to move the valves manually. The distribution valves moved freely, but the main valve was stuck in the closed position. The CE, EE, 2E and 3E inspected the position of the local control levers. These were arranged differently to the remote controls, and only the distribution valve controls were housed inside cabinets. There was a single control lever to operate the main pilot release valve and this was mounted on the panel with no form of enclosure (**Figure 3**). On inspection, the distribution valve controls were all found in the 'down' position. The main release valve control lever was found in the 'up' position.

Main release valve in the CO₂ room on Deck 5

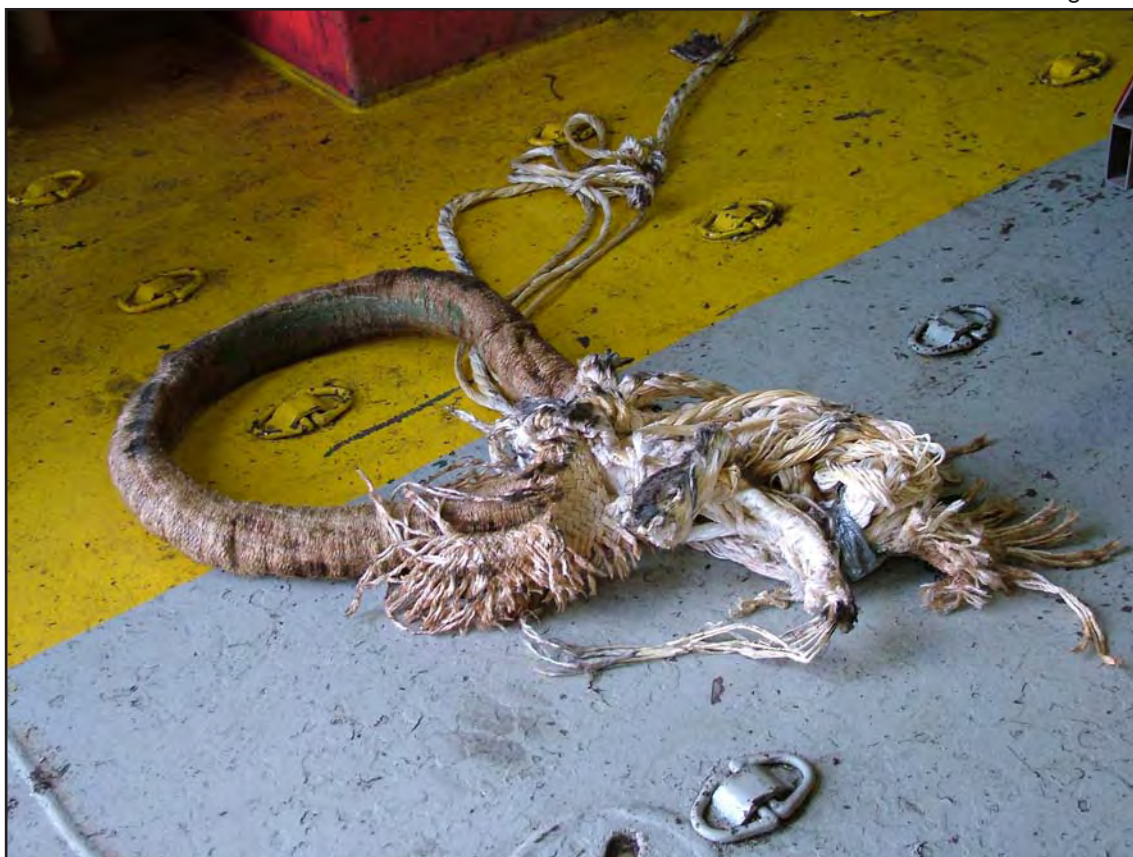
Remains of the soft eye of the tow line attached to *Figaro*

The soft eye was sent for detailed inspection and dissection by a specialist company, Tension Technology International (TTI) to determine why it had failed. TTI noted that the soft eye had become very stiff and, by comparing the rope core with the protective jacket, that it had contracted to approximately half its original length. This was caused by a combination of the rope cores pulling through the splices under extreme tension and compaction of the rope under recoil after it parted. The rope cores had failed at the splice, in two principal methods; four of the ten individual splices had slipped, causing the remaining strands to be overloaded. There was evidence of overheating with rope cores becoming fused together and further damage consistent with violent recoil. TTI concluded that the rope *“had been subjected to a severe load that had occurred quite quickly”* [sic].

Further work was done to establish the strength of the tow line and the suitability of the splicing method. The line was manufactured out of HMPE¹, which has a low friction coefficient. Although the splice had been done in accordance with the manufacturer's instructions, TTI reported that they and another major manufacturer recommended using 24 to 26 splices in this material to prevent the strands from slipping.

Undamaged rope yarns were taken from the sample and subjected to tensile testing. An analytical method was then used to estimate that the rope's residual strength after it had parted was in the order of 230 tonnes. It was also estimated from the general condition of the rope, that its minimum breaking load before the accident would have been about 75% of its value when new, giving 270 tonnes. The effect of the four slipped splices was considered to have reduced the actual breaking load by 25% and so it was concluded that the tow line would have parted at a load of about 200 tonnes.

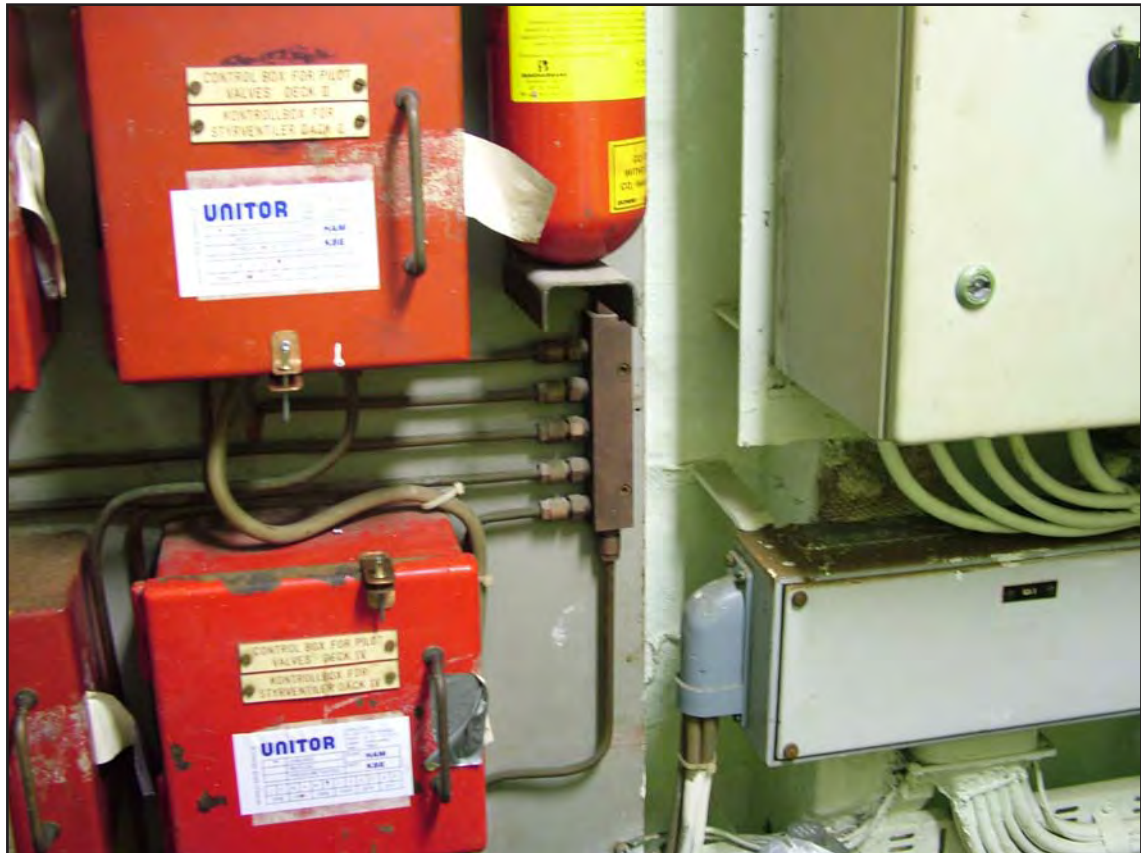
Figure 10

Manifold for MCU main pilot valve controls

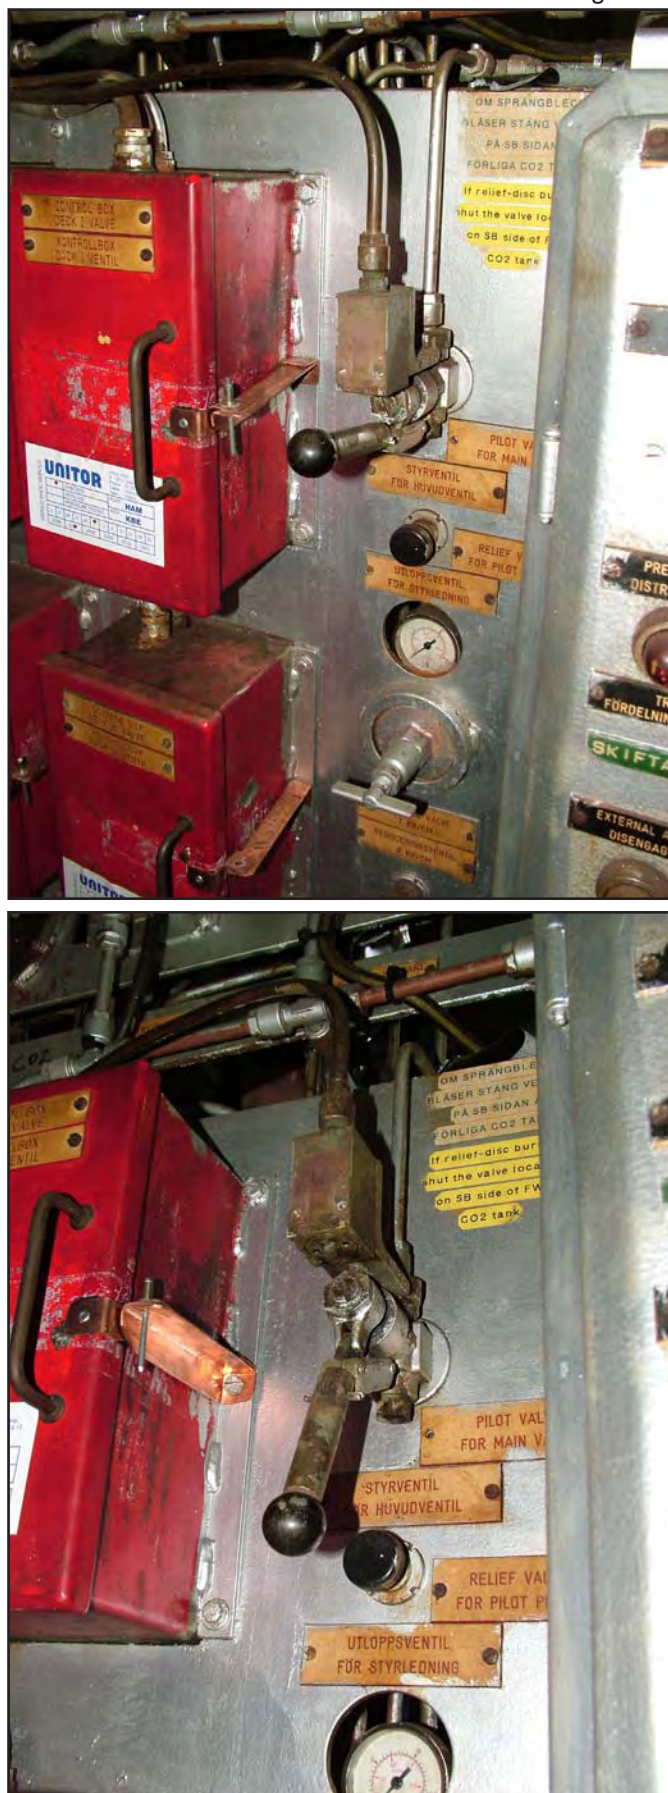
Figure 11

Main pilot release control valve on the CO₂ room
control panel

The main pilot valve (16A) was mounted so that its operating handle was horizontal when the valve was closed. In normal circumstances, it only needed to be moved a short distance (around 20mm) downwards, before the mechanism released and the valve handle fell to the vertical position under gravity. The valve handle should have been opened by the MCU remote piston during the earlier test, but there were two leaks and the piston was partially fouled, preventing it from moving throughout its full range of travel.

It is most likely, that during the routine test on 22 November, the remote piston moved a short distance, pressing up on the main pilot valve (16A) operating handle, before a combination of the leaks and fouled piston stopped it from pushing the handle fully downwards as intended. The lever would then have stayed in this position, with tension in the mechanism until 6 December.

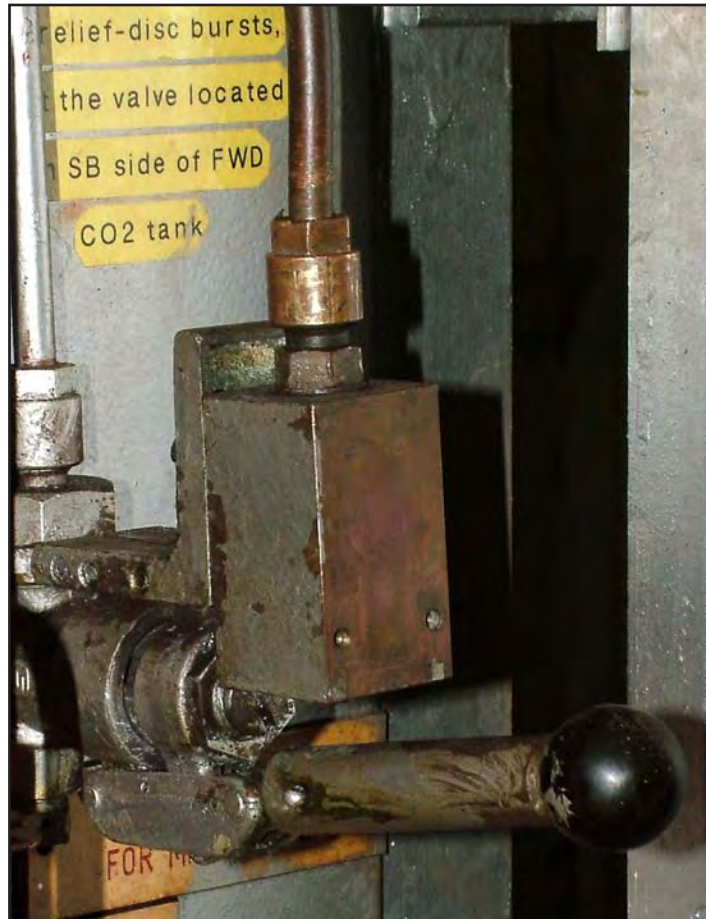
Figure 12

The control valve levers operated on the over centre principle, similar to a clasp found on a travelling case or ski boot. Pressure from the valve pin kept the lever in the closed position. A relatively small movement of the lever compressed the valve pin further, until the fulcrum of the lever hinge changed. Pressure from the valve pin then acted on the lever to move it further, releasing the pin and allowing the valve to open fully (**Figure 12**).

Main pilot release control valve arrangement

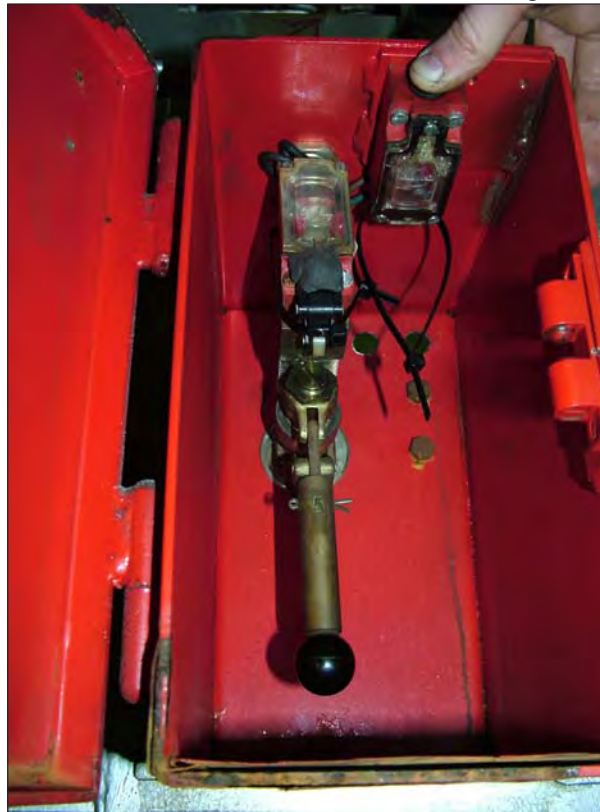
Figure 13

During the routine test on 22 November 2007, all of the operating levers in the Master Control Unit were pulled down from the vertical to the horizontal position, releasing CO₂ gas to extend each of the five pistons on the CO₂ room control panel. The cabinets on the CO₂ room control panel were kept closed and the 3E, witnessing the test, expected to see the large distribution valves operate. When there was no movement of the valves, the cabinets were opened and all five distribution pilot valve levers (16B to 16F) were found in the down (open) position (**Figure 13**). The main pilot valve lever (16A) was found in the horizontal (closed) position. However, there were no markings to describe what the positions meant. The CE was able to operate the distribution valves (4B to 4F) by hand, but could not open the main valve (4A).

Distribution valve pilot release control lever
