**MARINE INVESTIGATION REPORT**  
**M05W0111**

**LOSS OF PROPULSION, SUBSEQUENT STRIKING OF BERTHED  
PLEASURE CRAFT AND GROUNDING**

**ROLL-ON/ROLL-OFF FERRY *QUEEN OF OAK BAY*  
HORSESHOE BAY, BRITISH COLUMBIA  
30 JUNE 2005**

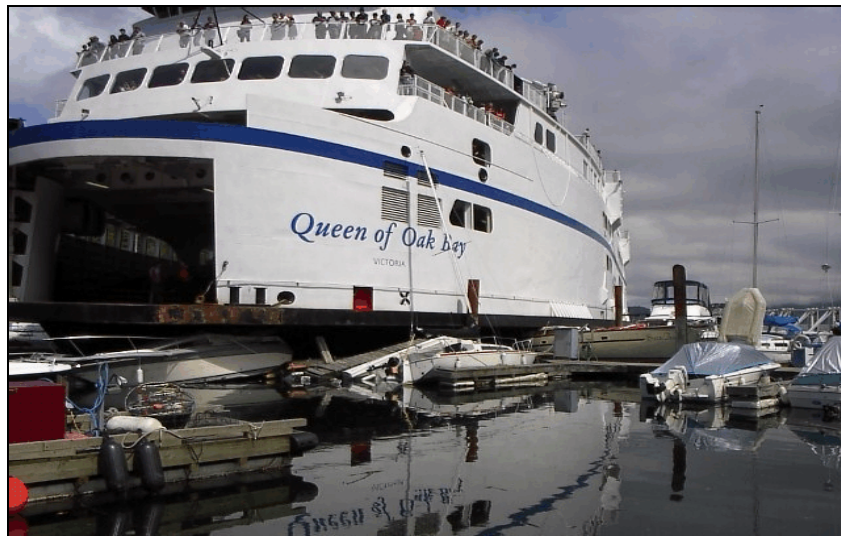
**Photo 1.** *Queen of Oak Bay* aground in Sewell's Marina

The vessel suffered minor damage to the No. 2 propeller and some scraping damage to its hull. There was extensive damage to the marina and 28 pleasure craft moored there.

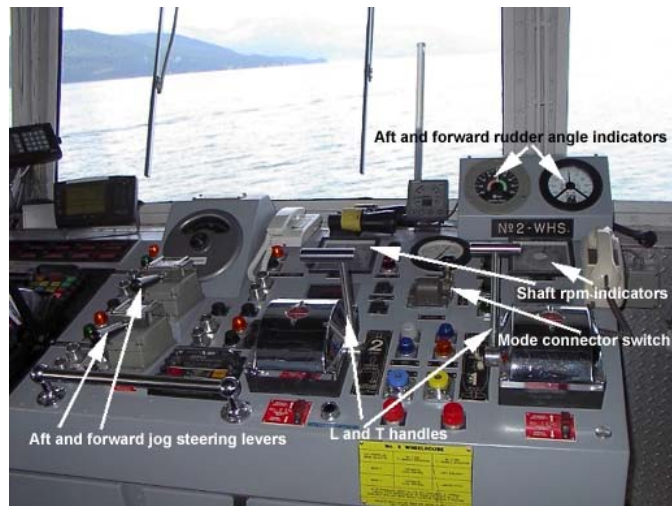
**Photo 2.** Wheelhouse control console

Wheelhouse manoeuvring consoles on C Class ferries do not have a mimic board showing the propulsion plant's condition. Relying on the propeller rpm gauges may therefore be misleading and, without gauges to likewise indicate engine rpm or the position of the clutches, it is impossible to tell if an engine is declutched but running, idling, or fully stopped.

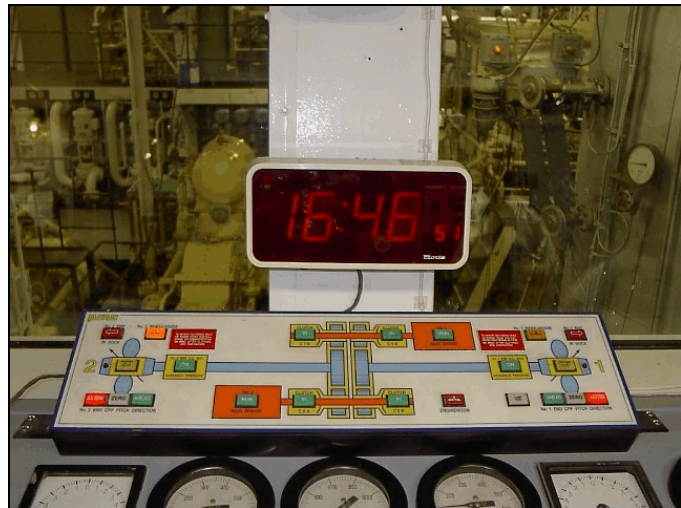
In the event of a malfunction, neither the engine control room nor the wheelhouse has a direct, audible alarm to alert operators to an accidental or inadvertent disengagement of one or more clutches.

**Photo 3.** Mimic board in engine room

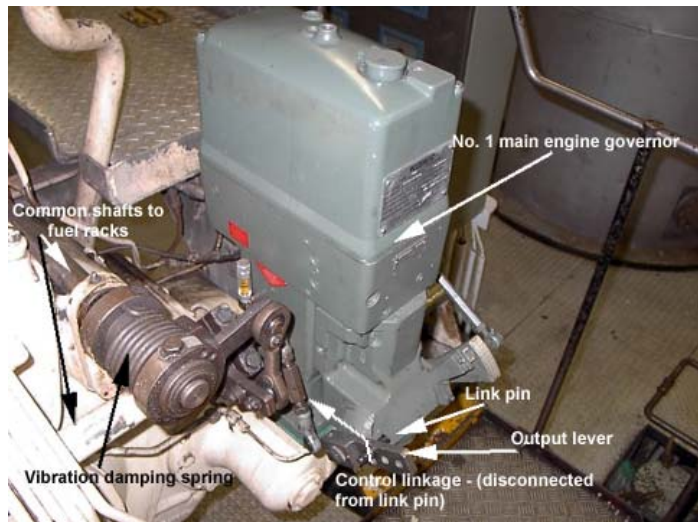
A castellated nut on the link pin for connecting the governor's output lever on the No. 1 main engine governor's output shaft to a control linkage was found on the floor plates beneath the governor. The linkage had slid out of the governor's output lever link pin, causing the governor to become disconnected from the engine's fuel control rack linkages (see Photo 4).

No broken pieces of the locking split pin were found in the vicinity of the nut, nor were any left behind in the bore of the link pin or the nut.

The orientation of the fitted link pin was contrary to that indicated in the manufacturer's drawings, which indicated that the pin was to be inserted with its head on the side of the link rod, with the nut lying on the outer side of the output lever. There was no indication that the orientation of the pin would have resulted in a detrimental effect or condition.

The link pin was designed to slide into its designated bored hole in the output lever. Wear from usage created an excessive clearance between itself and the bored hole.

**Photo 4.** No. 1 main engine governor and disconnected fuel rack linkage

The function of a governor is to limit an engine's rpm around a set point, preventing it from overspeeding. As the castellated nut loosened under vibrations, the control linkage fell out. This allowed the No. 1 main engine's governor to become disconnected from its fuel-control racks, leaving the engine without speed control. Neither the engine fuel-control shafts nor individual fuel pump racks were fitted with return springs (nor were they required to be). Therefore, overspeeding of the engine could not be prevented because the fuel racks could not be brought back to zero.

The absence of a split pin on the securing nut on a governor linkage of the No. 1 main engine thus caused the governor to become disconnected from the fuel racks. The two main engines were interconnected at this time, and this caused the overspeeding No. 1 main engine to drag the No. 2 main engine into a shutdown condition with it, leaving the vessel without propulsion.

The *Queen of Oak Bay* finished its MLU on 08 June 2005. Less than a month later, the nut worked itself loose and fell off. In order for this to occur, the locking split pin that is used to secure the nut was either not fitted or was fitted improperly.
