Report on the investigation of the
inadvertent release of carbon dioxide and disabling of

Figaro

off Wolf Rock

Report No 14/2008
August 2008

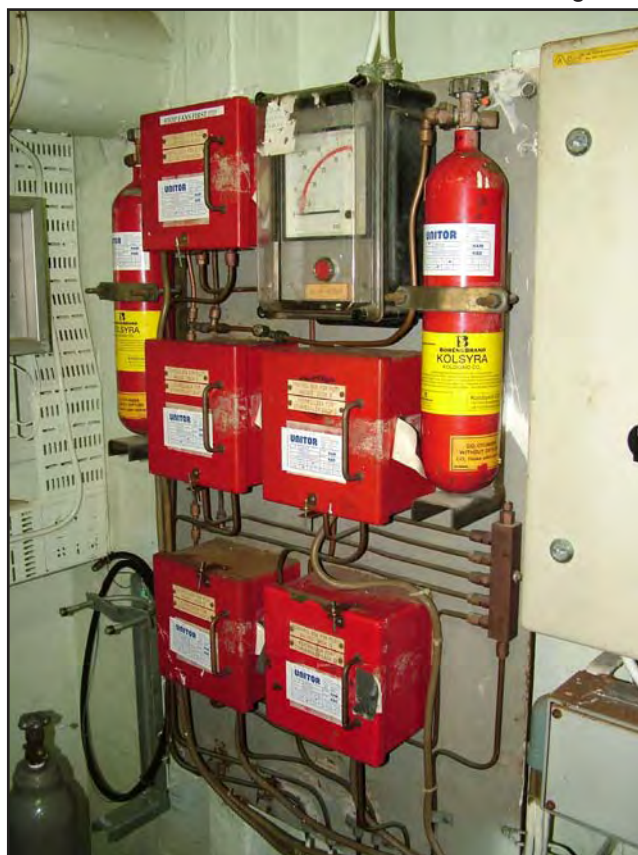
Figure 2

Master Control Unit (MCU) panel on Deck 14

There were no markings on the operating levers to indicate what the different positions signified, and there was little guidance in the manufacturer's manual to assist in diagnosing the problem. The CE concluded that the remote system had malfunctioned, but considered that in the event of a fire he could still release the CO₂ by opening the main and distribution valves manually. He was not sure what position the levers should be in and decided to leave them as they were found. The main stop valves on the CO₂ storage tanks were re-opened so that gas was immediately available in an emergency.

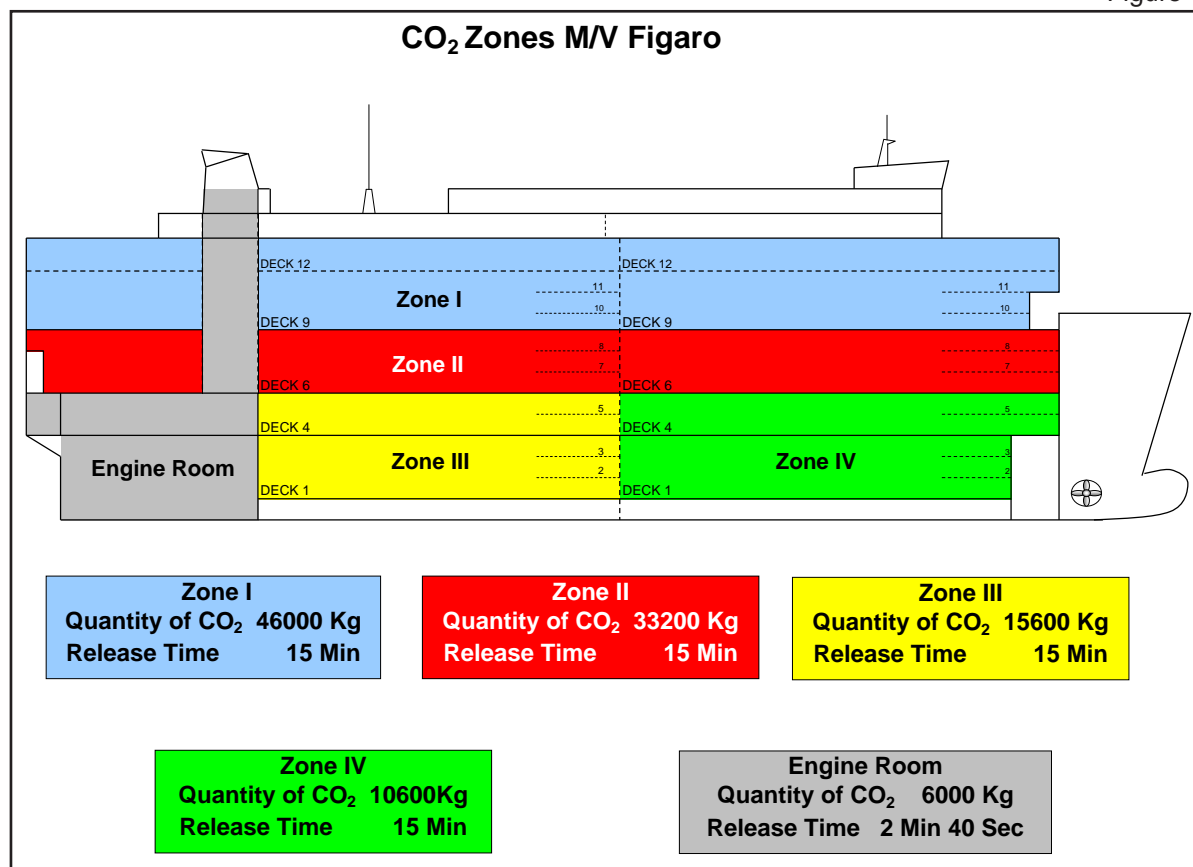
At the muster station, crew reported that fog from the discharging CO₂ gas had also been seen in the engine room and in cargo zone no.1 on deck 9. Sightings of CO₂ being released were confirmed in cargo zones 1, 2 and 3 (**Figure 4**) and in the engine room, the vast majority of the internal volume of the ship. The AB, who had made the initial report, and a cadet escaped from cargo zone 2 on deck 6, the fourth engineer and two engine room ratings had escaped from the engine room and another AB had escaped from cargo zone no.3 on deck 4. No CO₂ was released into cargo zone 4 at the lower, forward end of the vessel.

Schematic diagram of vessel showing CO₂ protected zones

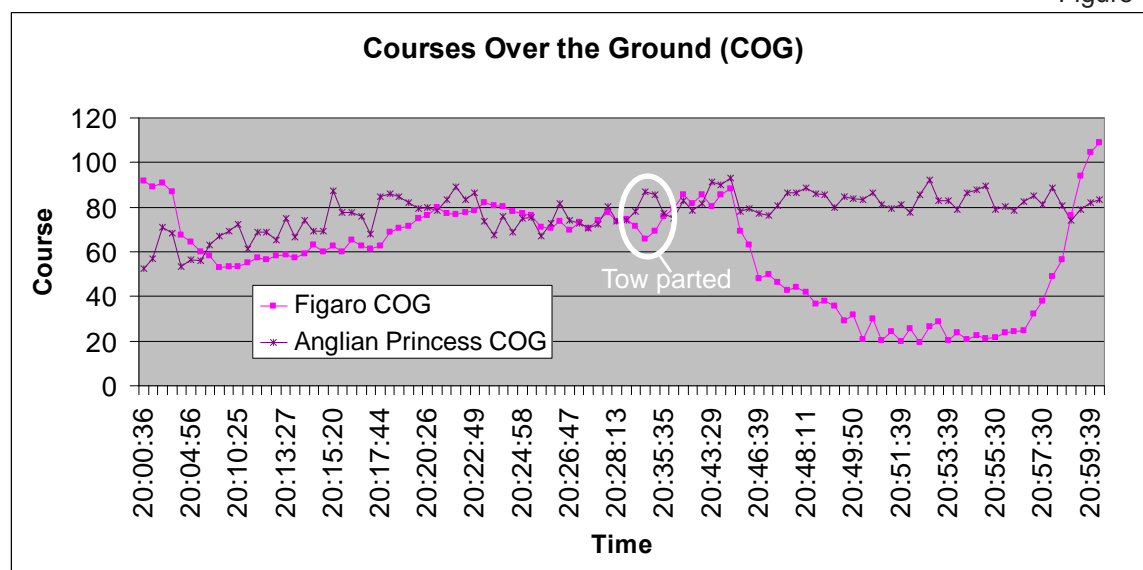
Figure 6

Study of AIS data shows *Anglian Princess* making good a course to the east at about 3.5 kts. At 2026 *Figaro's* heading begins to alter to starboard, turning through north and reaching 007° at 2029. The courses over the ground (COG) for *Anglian Princess* and *Figaro* begin to converge at around 074°. The next AIS data sample for *Figaro*, 3 minutes later at 2032, shows that the heading has altered, through 29° to port, to 338°. *Anglian Princess's* speed drops sharply from 3.7 to 1.4 kts and the courses over the ground diverge, *Figaro* altering to port to make good 065° and *Anglian Princess* to starboard to make good 085° (**Figure 6**).

Graph of *Figaro* and the ETV's courses over the ground

The crew of *Anglian Princess* saw the Dyneema tow line part. At 2034, Coastguard officers recorded that they had overheard Sennen Cove ALB reporting to *Anglian Princess* that the line had parted, making a loud crack as the line went slack. *Anglian Princess* recorded in their log that the tow line had parted at 2015, but the Coastguard had also recorded *Anglian Princess's* report that the tow was underway at 2020. It has not been possible to determine why there is a discrepancy between Coastguard and ETV timings.

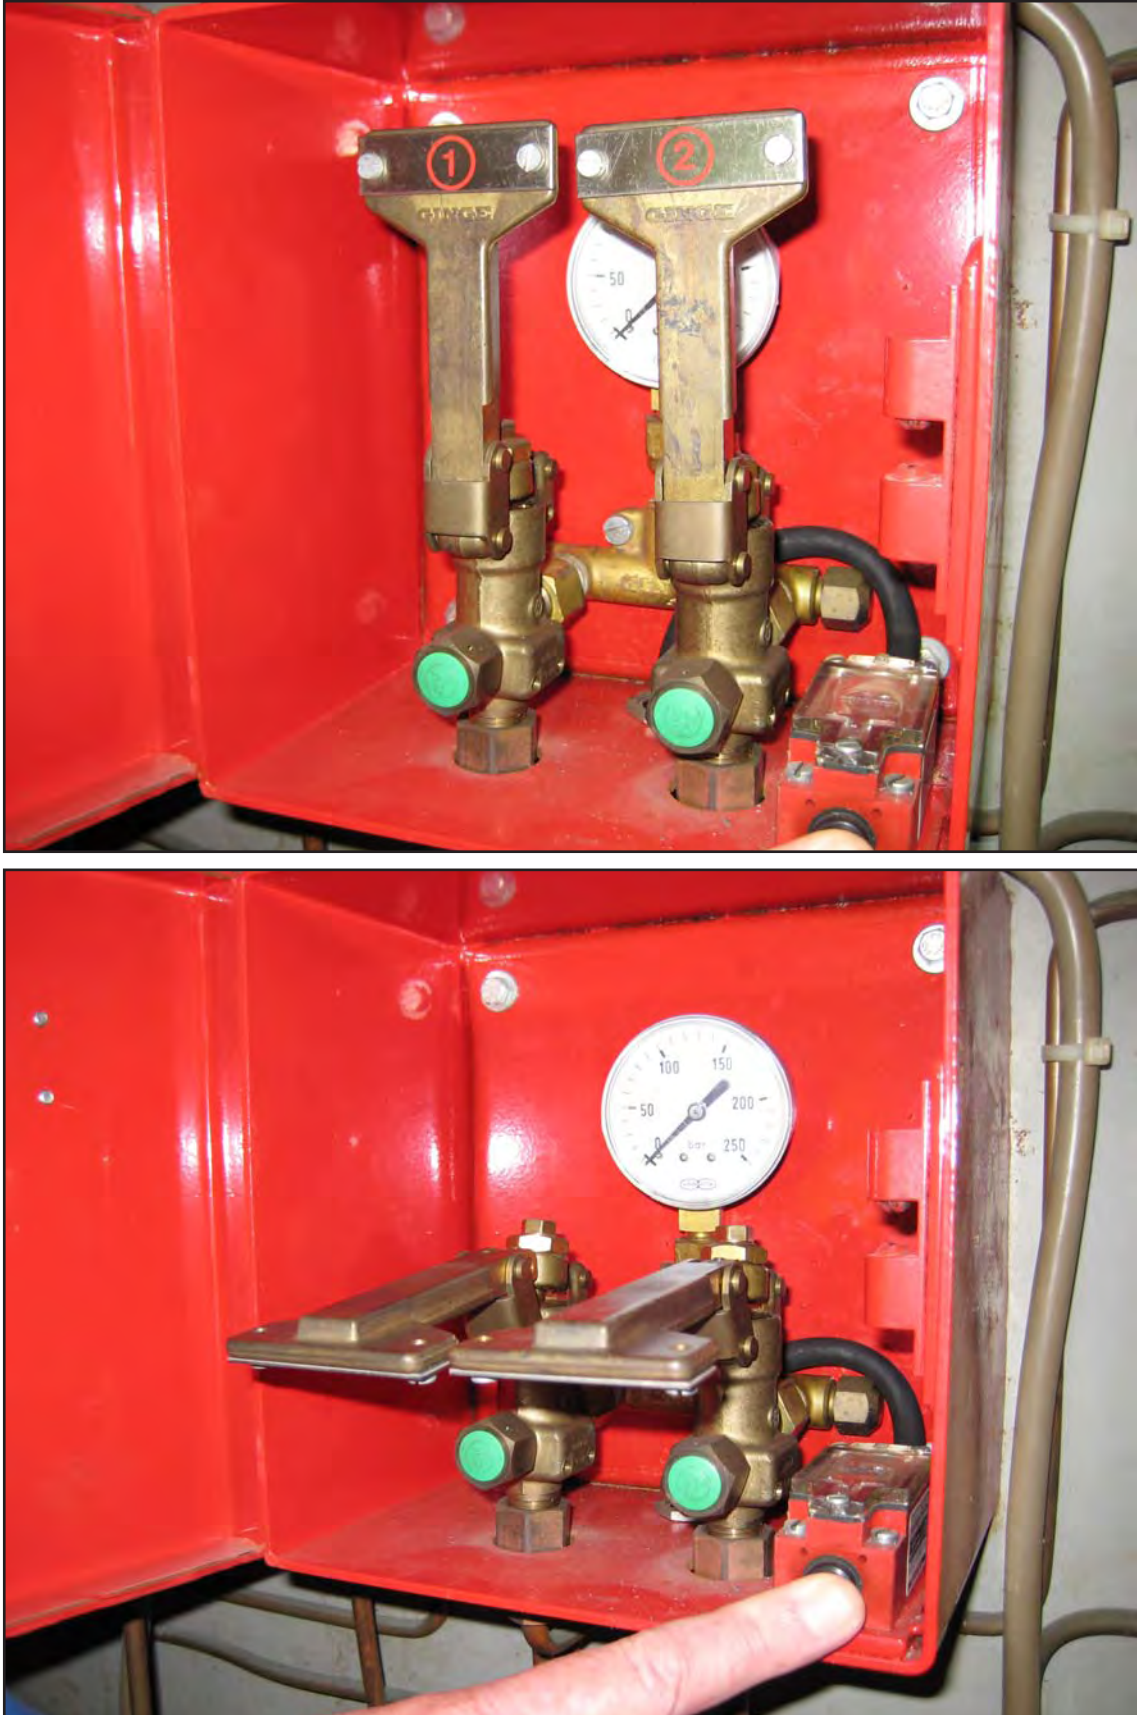
Main Control Unit operating levers

releasing low pressure gas from the small Master cylinders. The distribution controls had separate pipework connecting each of them directly to the respective control in the CO₂ room. However, each of the five different remote controls for the main valve terminated at a non return valve and then joined a common manifold (**Figure 10**). A single pipe from this manifold then lead down from deck 14 to the main valve controls in the CO₂ room. The control lever valves were self purging, with pipework open to the atmosphere when closed and only sealing once operated. The non return valves were required to prevent gas pressure from an opened control valve escaping back through any of the unused control valves.
