**MARINE INVESTIGATION REPORT**  
**M05W0111**

**LOSS OF PROPULSION, SUBSEQUENT STRIKING OF BERTHED  
PLEASURE CRAFT AND GROUNDING**

**ROLL-ON/ROLL-OFF FERRY *QUEEN OF OAK BAY*  
HORSESHOE BAY, BRITISH COLUMBIA  
30 JUNE 2005**

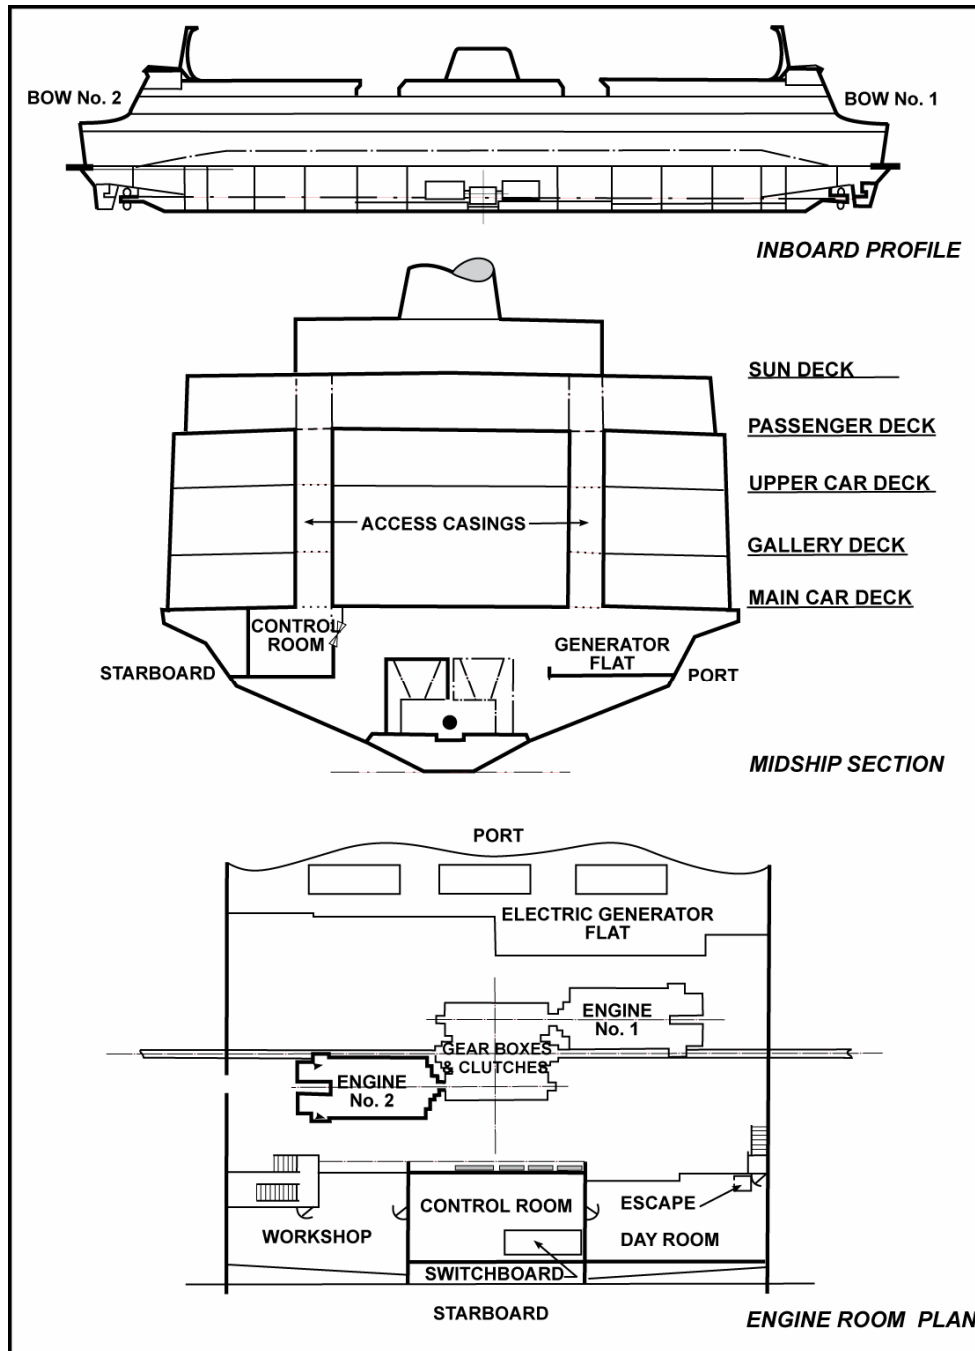
The *Queen of Oak Bay* is a double-ended vessel having a wheelhouse, a controllable-pitch propeller and a rudder at each end, and the engine room at midships. The two ends are almost identical and, for the purposes of identification, are numbered 1 and 2. This establishes the port and starboard sides of the vessel and the numbering system of the machinery in the engine room (see Figure 1).

Figure 1. General arrangement of compartments at midships

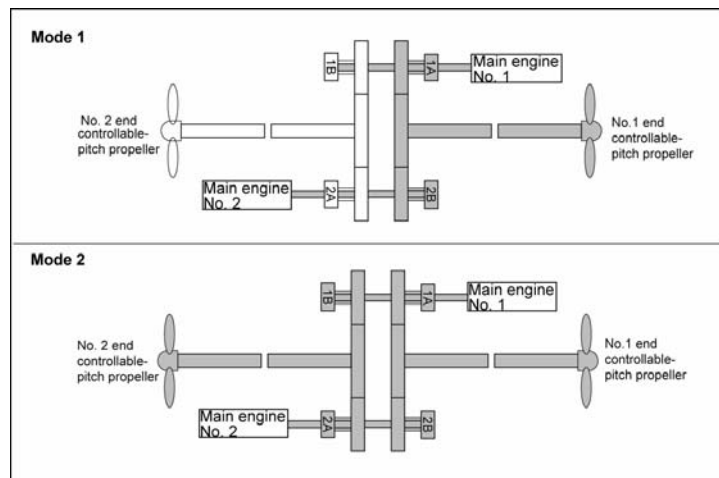
All four clutches are engaged, providing power to both propellers. This mode is primarily used during berthing and unberthing. The amount of power absorbed by each propeller can be varied by adjusting the blade pitch, but the default is a ratio of 70:30 or 60:40, with the forward propeller taking the lesser amount, because it is used to slow the vessel.

Figure 2. Mode 1 and Mode 2

In both modes, the two main engines are mechanically coupled, effectively behaving as a single unit. There is no automatic means to isolate them in the event of a fault in one; any change in the operating condition of one is automatically, and instantaneously, reflected in the other.<sup>5</sup>

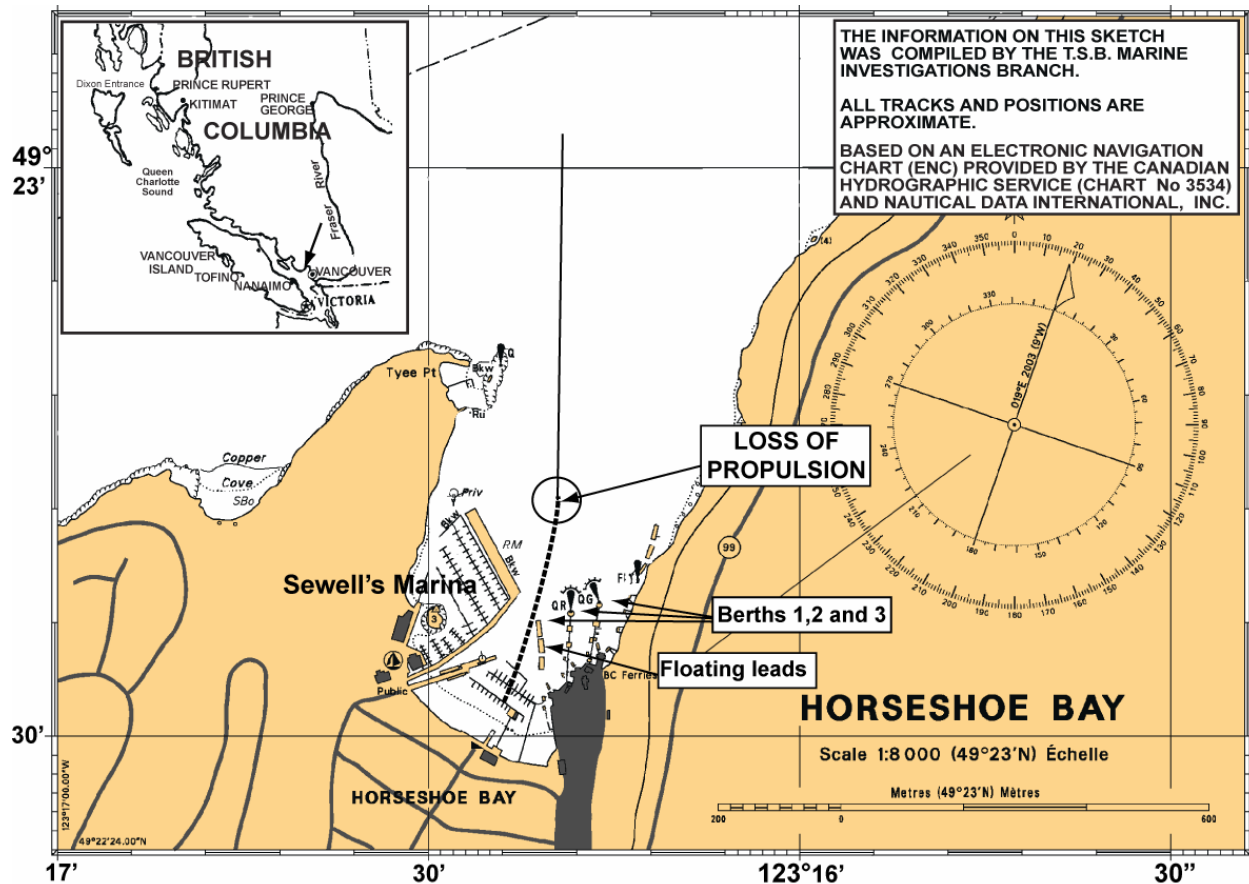
Figure 3. Aerial view of Horseshoe Bay (courtesy of BC Ferries)

At 1002, the master placed the engine room on “standby” for arrival at Horseshoe Bay and at 1005 changed over to Mode 2, engaging all four clutches. The vessel was lined up for the centre of the No. 1 berth, but at 1008, while about 200 m away from the floating leads, all propulsive power was lost. Seeing that the propellers had stopped turning, the master telephoned the engine room, informed them of the power loss, and ordered the engines to be restarted and power restored.
